## Temporal development of hull-fouling assemblages associated with an Antarctic supply vessel

Marine Ecology Progress Series 386:97–105 (2009)

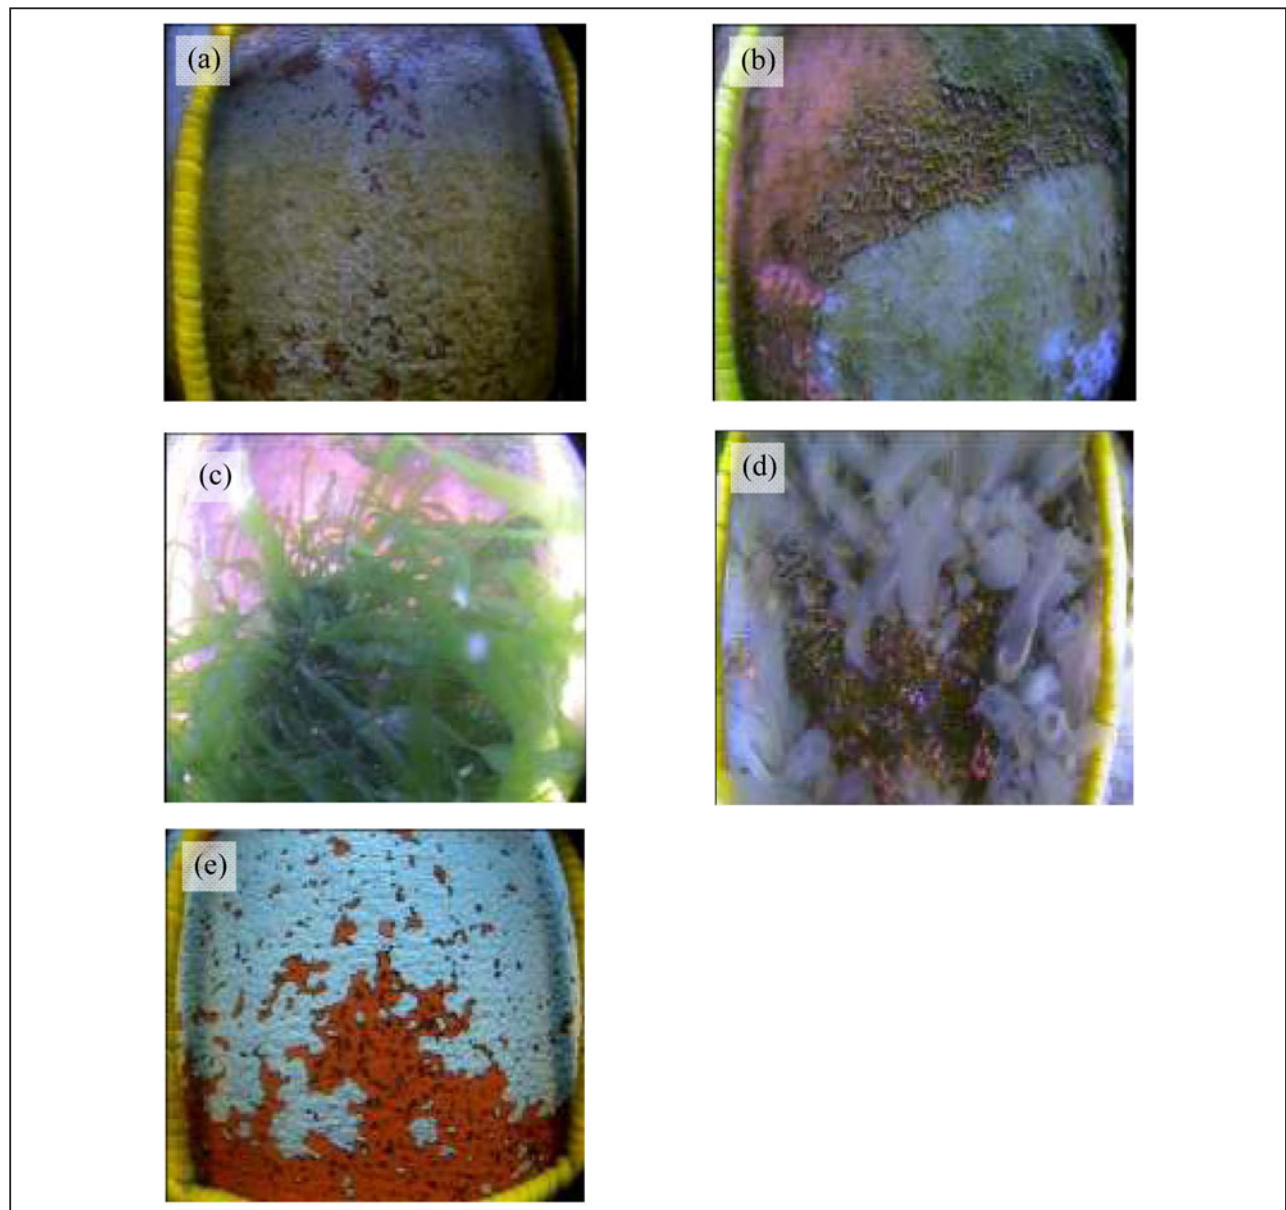
Fig. S1. Still images extracted from video surveys of hull fouling (area surveyed = 0.01 m<sup>2</sup>) on the SA 'Agulhas' during cruises in 2006 to 2008, showing (a) 80% coverage with biofilm, (b) 30% coverage with filamentous algae and 50% coverage with biofilm, (c) 50% coverage with macro algae (*Ulva intestinalis*), (d) 30% coverage with filamentous algae and 70% coverage with macrofauna (*Ciona intestinalis*), and (e) 60% removal of anti-fouling coating
